## ASBESTOS-CONTAINING MATERIAL (ACM) SURVEY AND ABATEMENT COST ESTIMATE

BLM Task Order 135, BPA L09PA00228 (NAB060001 Legacy Number)

**L3543 MONTROSE WAREHOUSE (WEST)**  
**38.45965 / -107.86798**  
**UNCOMPAHGRE FIELD OFFICE COLORADO**

**Re: Asbestos-Containing Materials Survey and Asbestos Abatement Cost Estimates**  
L3543 - Montrose Warehouse (West)  
Uncompahgre Field Office, Colorado  
ATC Project Number 35.21320.0001, Task 00025

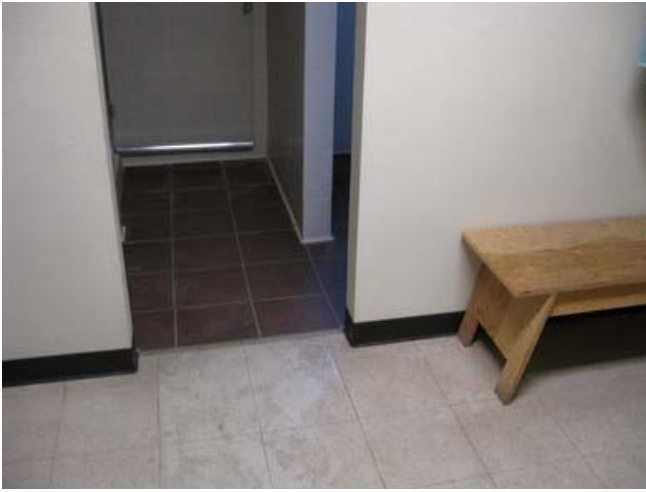
| ACM BULK SAMPLING RESULTS<br>L3543 - Montrose Warehouse (West)<br>Uncompahgre Field Office, Colorado | | | | | | | | | | |
|---|---|---|---|---|---|---|---|---|---|---|
| 12” x 12” Floor tile and mastic | M | 3 | 3 | MWW – 14, 15, 16 | Eye wash station, Office, Hallway, Women’s shower and locker, Men’s shower and locker | G | No | 880 SF | 15% | \$6,000.00 |

1: Asbestos-containing 12" x 12" floor tile and mastic.

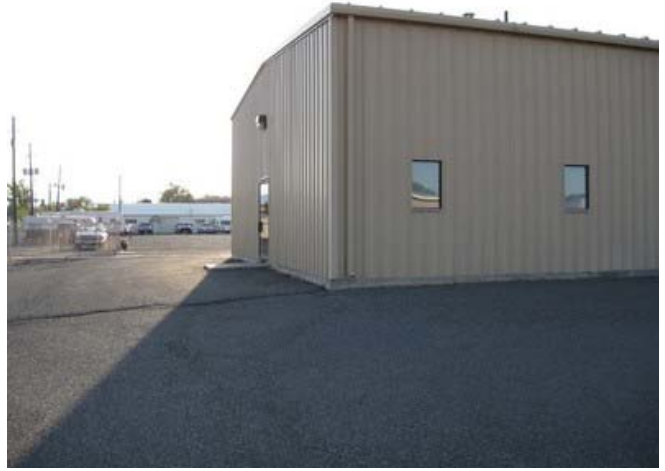
| ACM BULK SAMPLING RESULTS<br>L3543 - Montrose Warehouse (West)<br>Uncompahgre Field Office, Colorado | | | | | | | | | | |
|---|---|---|---|---|---|---|---|---|---|---|
| Roof seam sealant | M | 3 | 3 | MWW – 23, 24, 25 | Roof | G | No | 440 LF | 10% | \$3,500.00 |

2: Location of asbestos-containing roof seam sealant (top of photograph).
