# ENGINEERING REPORT

## PALISADES ADMINISTRATIVE SITE LAGOON LINER AND EFFLUENT SPRINKLER SYSTEM REPLACEMENT

PIMA COUNTY  
SANTA CATALINA RANGER DISTRICT  
CORONADO NATIONAL FOREST

SOUTHWESTERN REGION  
U.S. FOREST SERVICE  
UNITED STATES DEPARTMENT OF AGRICULTURE

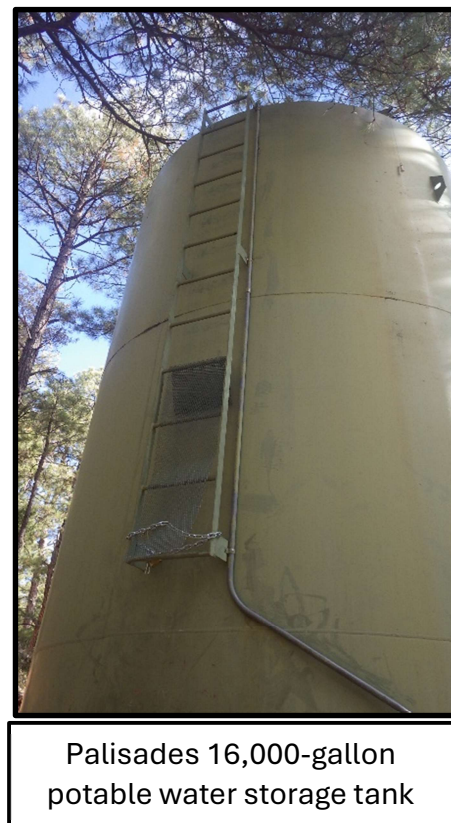
The 16k tank is equipped with a ladder that does not comply with current OSHA requirements. The ladder is kept locked at the bottom with a fine grated mesh to prevent any access to the top of tank. The existing exterior surface coating is slightly chalky and no past documentation of previous work on the tank. There is no standard manufacturer plate on tank to show the original thickness of shell or floor or year of construction. The operator does not have a way to monitor the water level inside this tank since there is no exterior water level gauge. The tank water level sensors are no longer automatically re-filling the tank because of needed electrical repairs. Due to the unknown construction year of the tank, it is recommended to complete a lead-based paint test. The tank appears to be structurally sound and may be able to receive improvements to the interior and exterior coatings. It is recommended to obtain a full tank assessment to measure the steel thickness for the shell, foundation evaluation, water level indicator, check for auto-fill controls, overflow pipe, access ladder, roof, roof hatch, air vents, cathodic protection, water

quality, site security, man ways, inlet/outlet, and cleaning and removing sediment and receive written recommendations for corrective actions. Market research was completed on a tank assessment and these estimates are shown in [Appendix H](#).

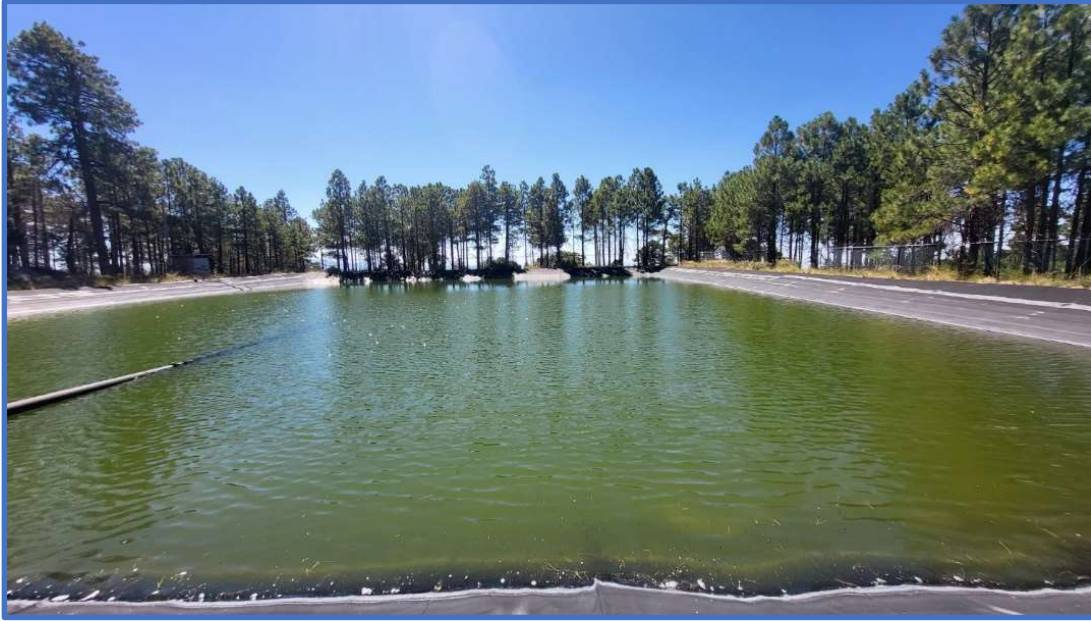
*Figure 3 - Palisades Administrative Site Lagoon*

The existing wastewater system at this site is a facultative lagoon. It is not aerated. The lagoon liner and effluent sprinkler system was entirely replaced in June, 2001. The current condition of the entire wastewater system has experienced wildfire and sustained damage to the liner which is deteriorated. The dimensions of the lagoon are approximately 154' wide x 179' long and 6.5' – 7.2' deep with 3:1 slopes. The perimeter is fenced with 6' high chainlink with three rows of barbed wire at the top with locks at the entry. There are minimal signs along the fencing.

1. Propose to replace the lagoon liner with geosynthetic liner in combination with non-woven geotextile. Recommended geomembrane liners include either a 45-mil polypropylene or 60-mil High-density Polyethylene with a heavy 8-oz non-woven geotextile.

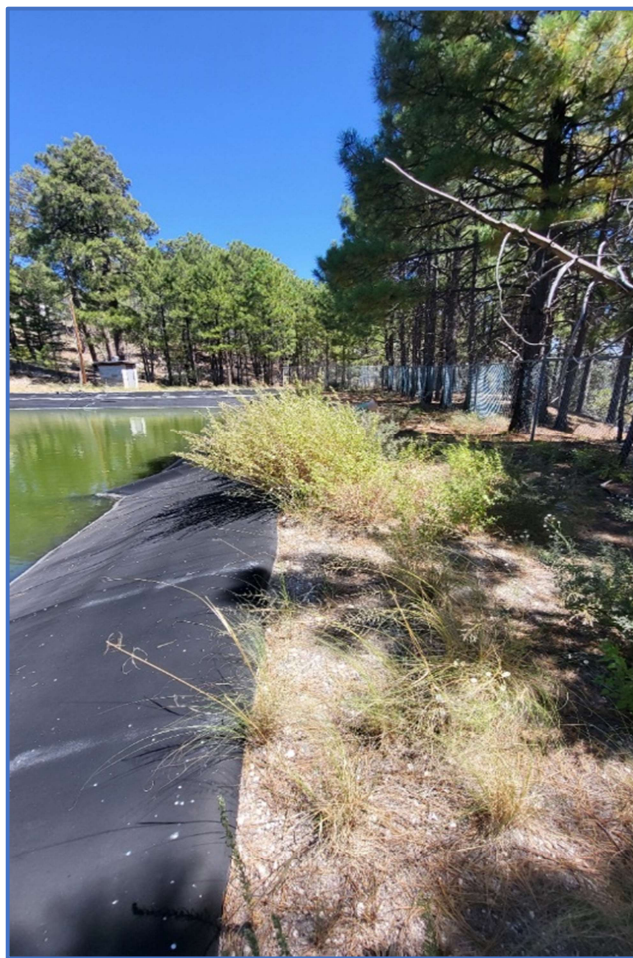
Vegetation Along Edge of Lagoon

The current deficiencies include repair of the existing effluent irrigation pump. The pump would not start, so it was removed for repairs and currently scheduled to be re-installed. It is unknown if the past wildfires damaged any of the sprinkler heads in the disposal area or any other wastewater system components above grade. The vegetation is overgrown and larger shrubs with roots have started to encroach along

the top edges of the liner (see photo to the left). There are trees growing near the lagoon and trees must not be allowed to grow in either the base or on the banks of the lagoon. (see photo above).

Within the lagoon, there is vegetation including brush, shrubs, and small diameter ponderosa pine trees. These should be cut and removed from the edges of the lagoon cell.

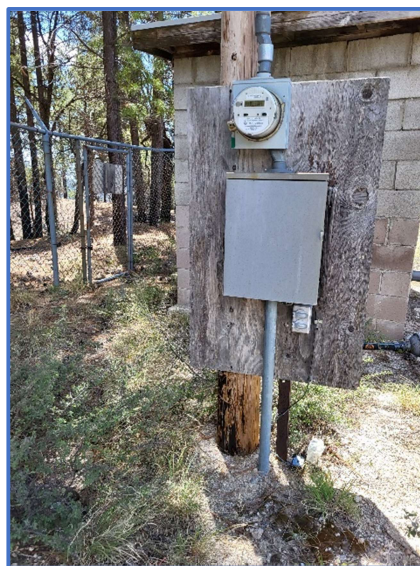
There is a power pole near the lagoon pumphouse which has a meter and panel with duplex receptacle.

Existing Electrical Meter and Panel with Duplex Receptacle

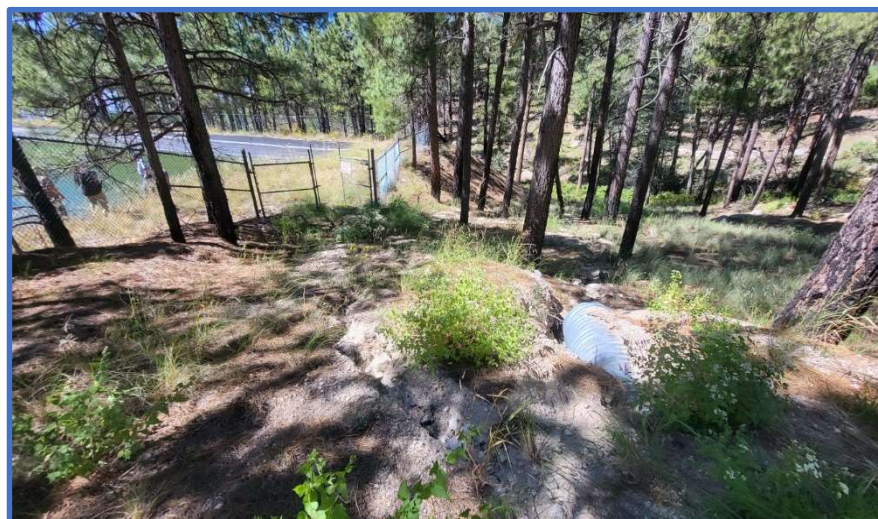
The photo below shows a steep section of the service road which eroded cover over the existing culvert. This portion of road was analyzed for improvement, reducing the existing slope from 22% to 12% which would require lowering the existing grade between 3 to 4 feet. At this depth, there is an existing section of sewerline that crosses the road and would encroach the required minimum cover. If this section of road is lowered, the existing sewerline will not have the required minimum of cover and would need a costly alignment change making this work impractical. Therefore, regrading and surfacing the road will be adequate for project completion. The existing culvert will be removed and re-installed at the same elevation and protected with rip rap to minimize erosion.

Service Access Road to Lagoon

6. The drainage will also be improved along the service road. The road receives surface flow from the upper sloped hill so road ditches will be constructed. There is a section of the road with steep slopes and creating severe erosion so this section will be corrected by lowering the elevation of the existing road and culvert and adding riprap to minimize the erosion.

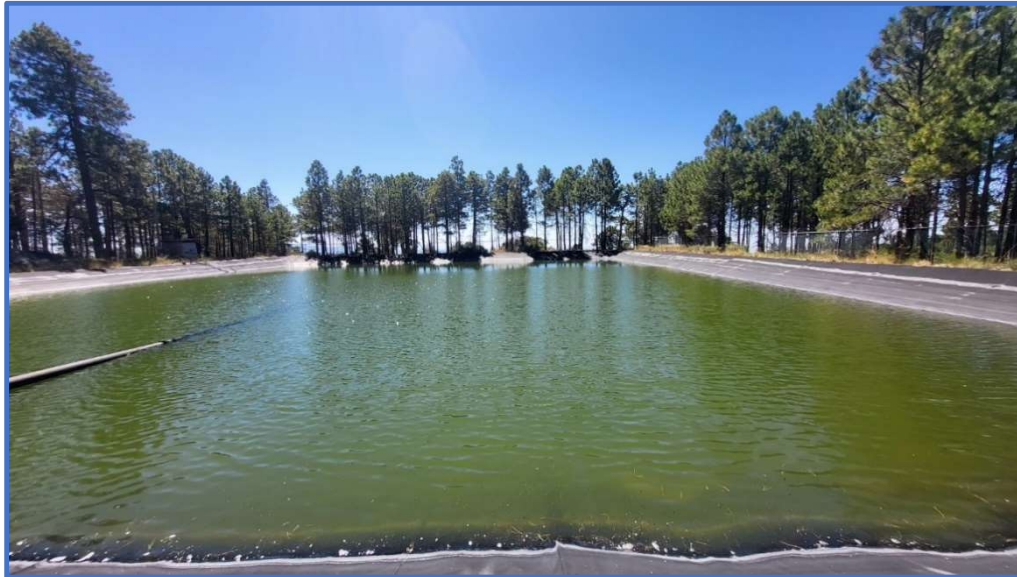
Palisades Administrative Site Lagoon (taken 9/12/2024)

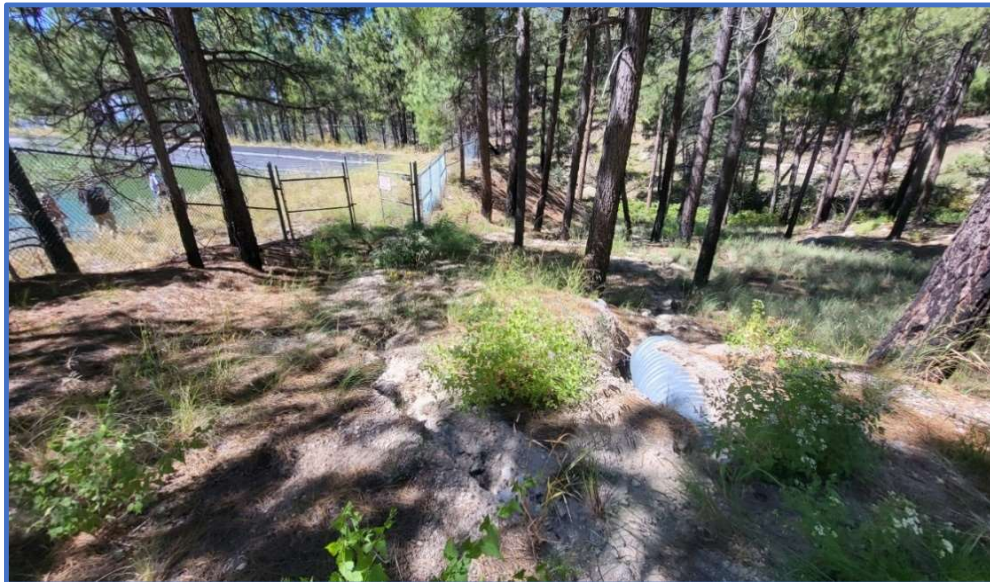
Eroded Service Access Road with Exposed Culvert & Erosion  
(taken 9/12/2024)

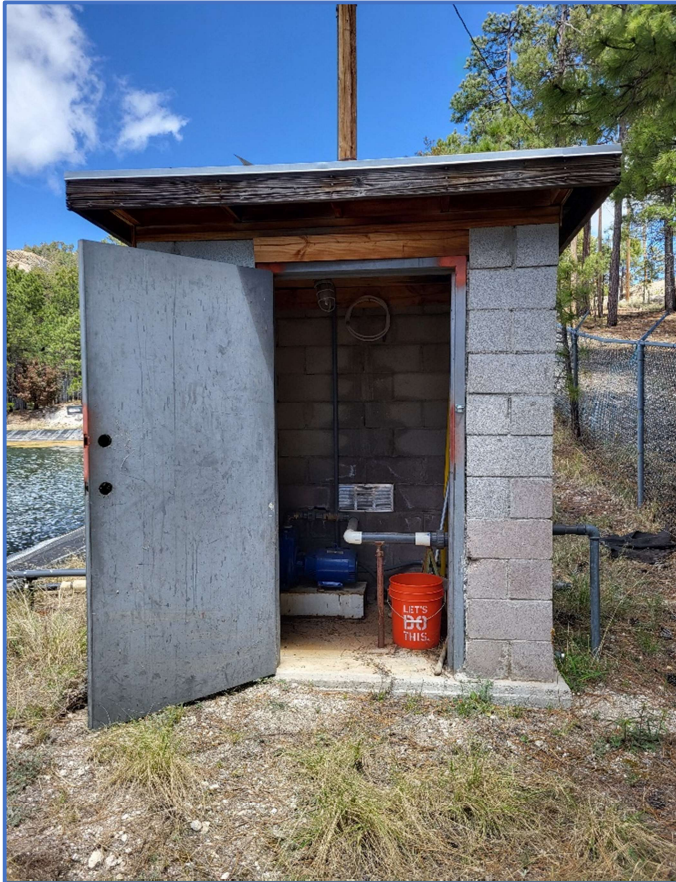
Palisades Lagoon Pumphouse

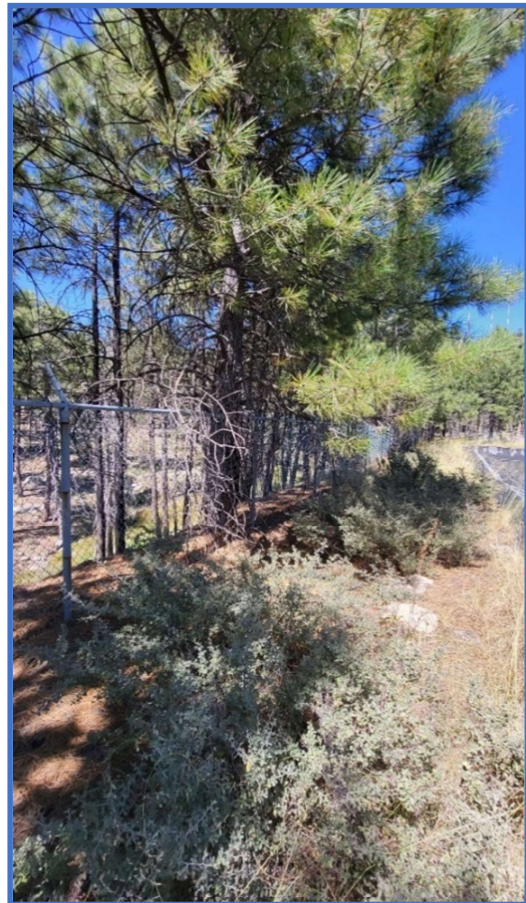
Vegetation along banks of Lagoon
